Track Pans and the B&O *Royal Blue* Line

By R.N. Nelson

EM-1 Update

Airslide Covered Hoppers of the Baltimore & Ohio

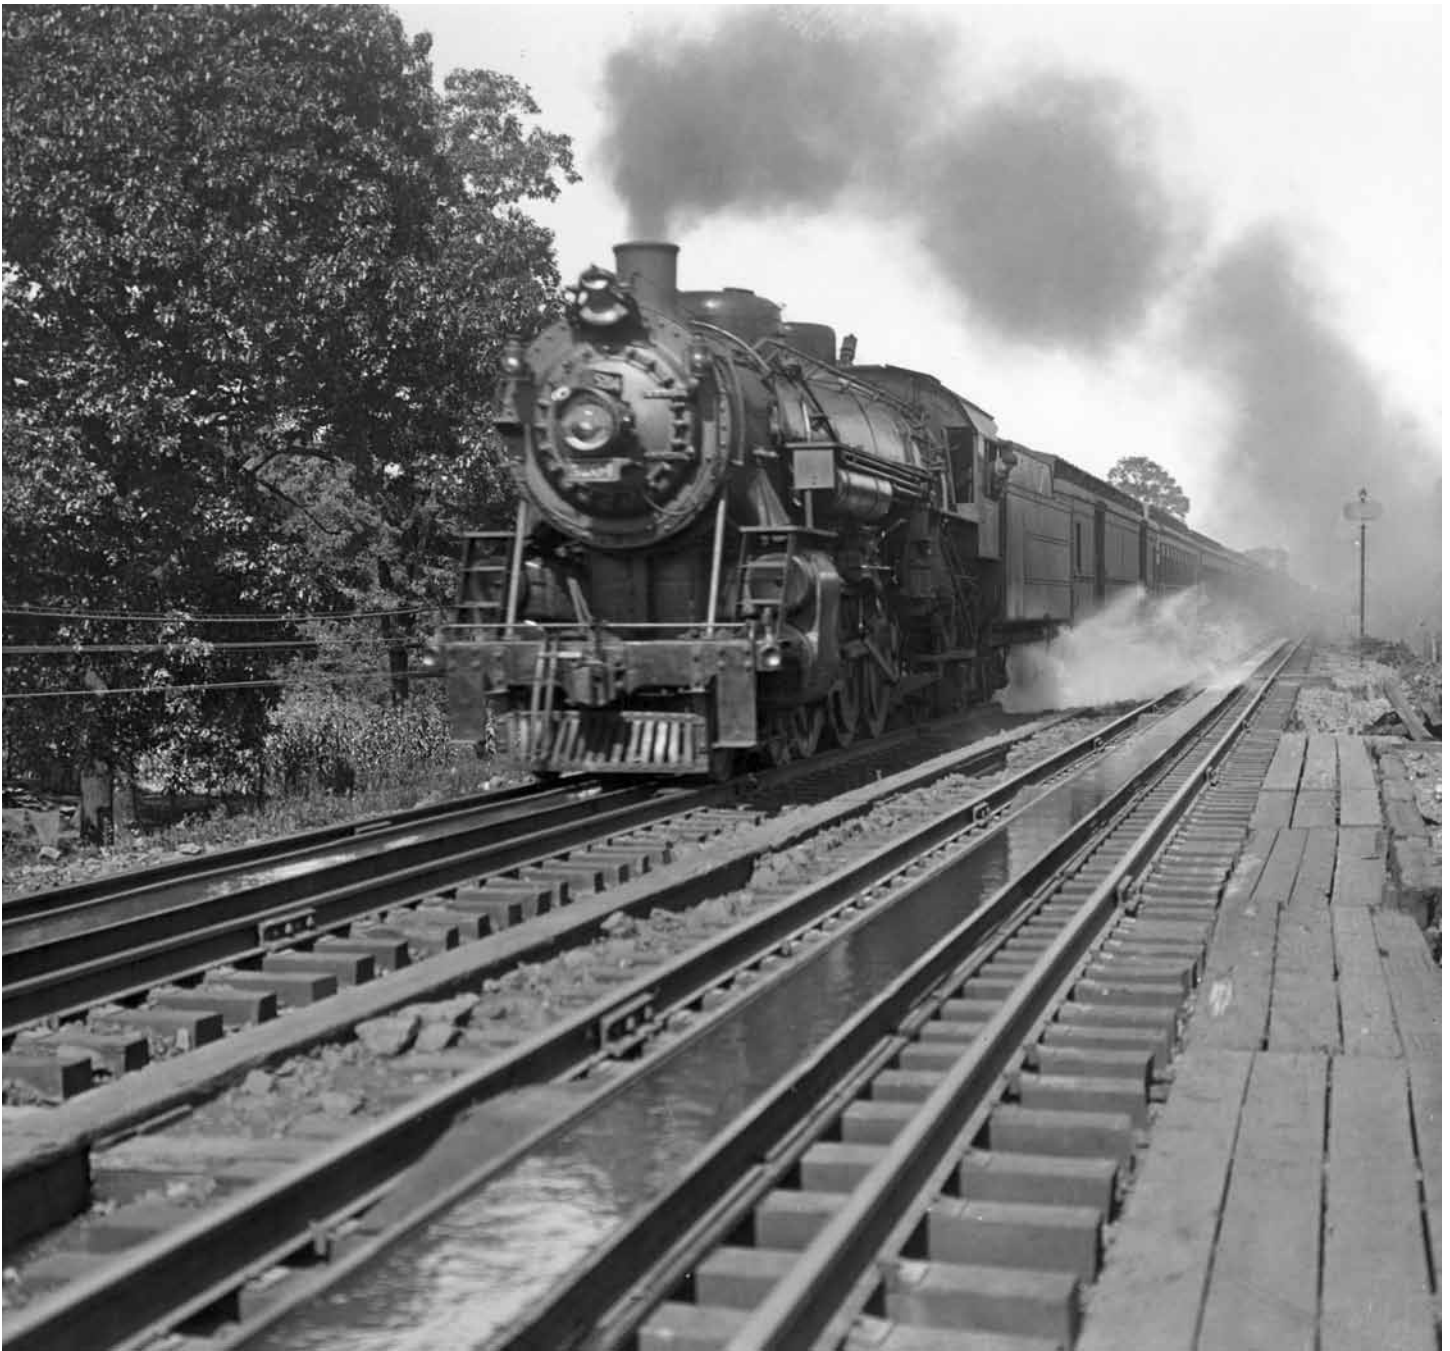
Westbound at Swan Creek, Maryland, engine 5204 exemplifies the B&O's class P-5 USRA Pacifics, delivered in 1919 and the mainstay of the motive power on the Royal Blue Line. In 1926 it would be the first B&O locomotive class to work through from Washington to Jersey City, only to be displaced in 1927 when the class P-7s arrived. The photograph is circa 1920, prior to the track pan area's being paved with Belgian blocks. Note the covered steam line running between and parallel to the tracks.

To increase their operating range, in 1926 some of the P-5 Pacifics' tenders were extended 10 feet, increasing the "as

delivered" coal capacity from 14 to 16 tons and the water capacity from 10,000 gallons to 10,800, somewhat resolving the low-water concern. As always, there was a trade-off—the affected engines required a 90-foot turntable. All were hand-fired and did not receive stokers until 1940.

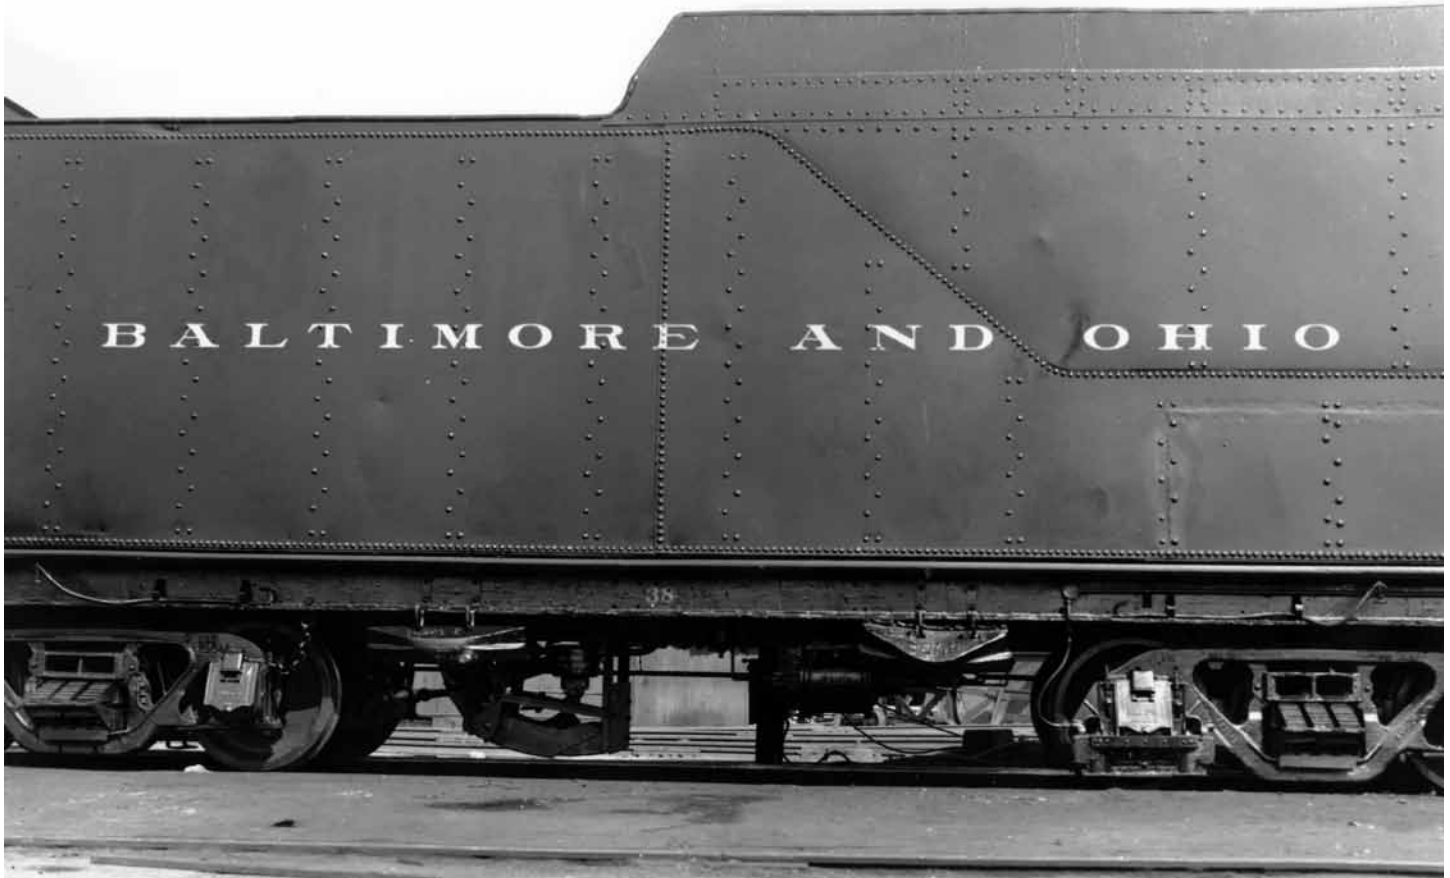
Some of the P-5 Pacifics used in *Royal Blue* service had their tenders extended 10 feet so they could hold 16 tons of coal and 10,800 gallons of water. But the longer range brought with it a need for bigger turntables. The tenders of P-7s could carry 19½ tons of coal and 11,000 gallons of water.

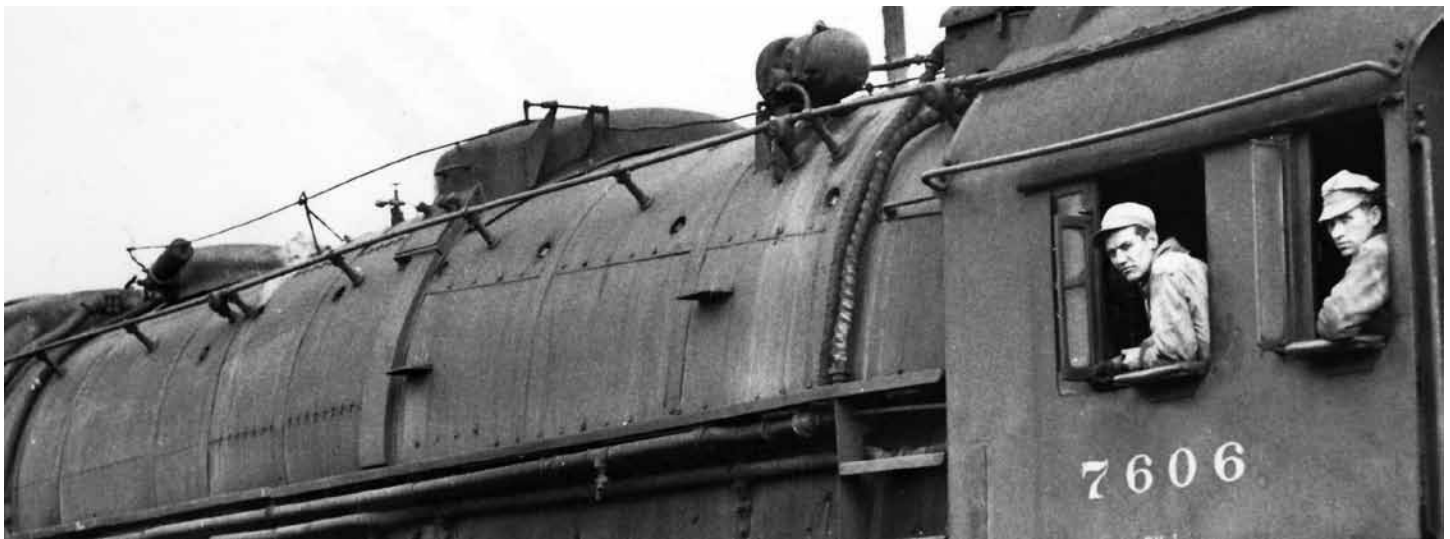
The cab crewmen are likely wondering what the photographer finds so interesting; for them it's just another day aboard an EM-1. For railfans, it's an excellent opportunity to study the rod, crank, bracket and rope system that was used on all of the big locomotives, one of the few things that can be cited as "standard" on a railroad known for expediency.

Most brass models do not have an accurate representation of the whistle linkage on the B&O EM-1s. From the whistle to a bracket behind the rear sandbox the linkage is a rod, not a rope; photos show this clearly. The rod went through a support bracket midway between the steam dome and the sandbox, and connected to a cam that rotated on a shaft placed on two supports behind the sandbox.

Outside the inner supports of the rear bracket hung a cam at the same angle as the outside cam. To this was attached a

pull cord that went inside the engine cab on the engineer's side.

The supports on the rear bracket were trapezoidal plates attached to the rear sandbox. For the rivet counter this is an important detail in prototype modeling.

As the years went by in service the rods were bent and became wavy from crews stepping on them.

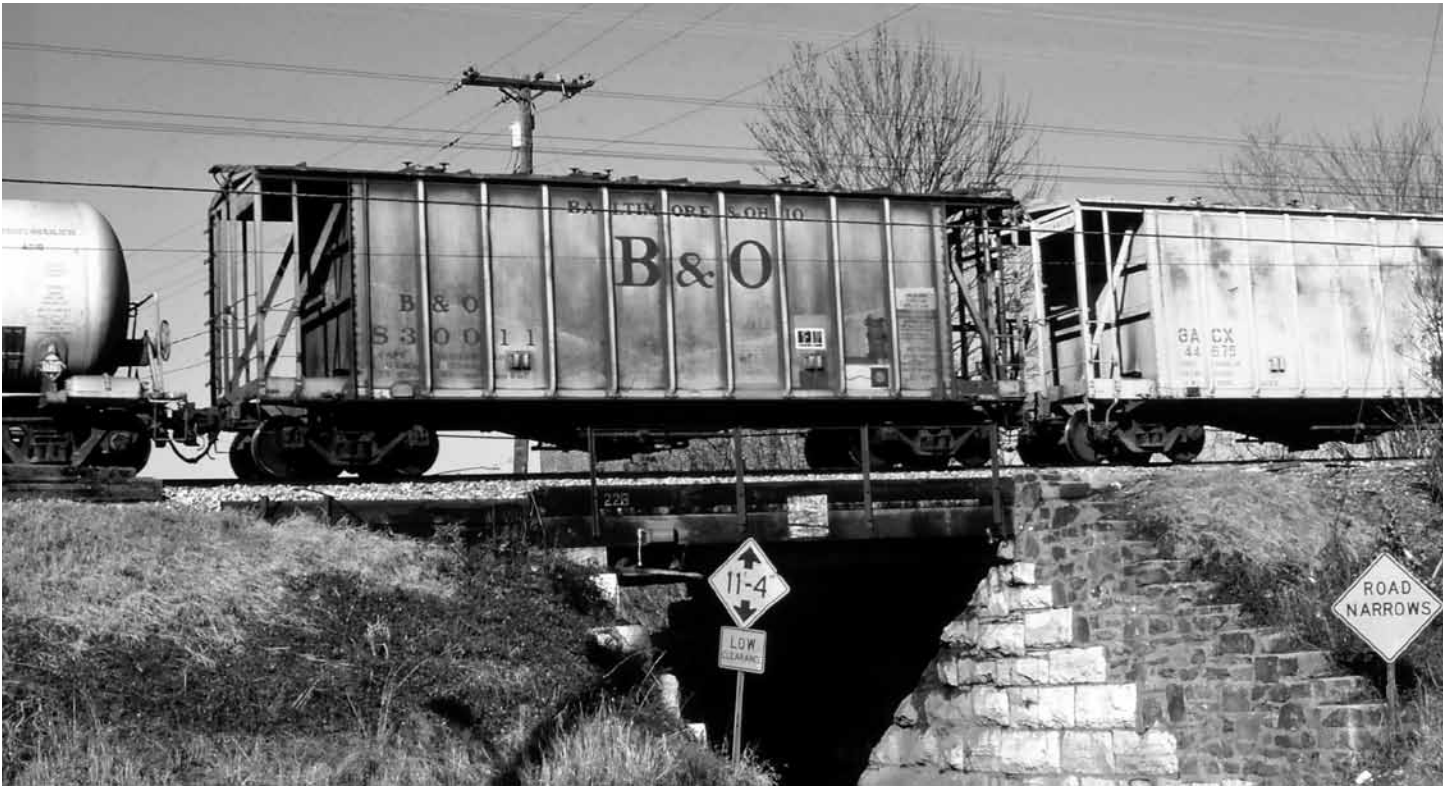
B&O Airslide covered hopper 830011 was in a train passing the station at Laurel, Maryland, when author Jim Rogers took this picture. Part of the first series of N-47s built in 1960, it had friction-bearing trucks carrying a light weight of 56,500 pounds.

The design featured hopper bays formed into deep troughs lined with a layer of air-permeable fabric.

The customer receiving the load would need a source of compressed air to connect to the car for unloading.

The original design was for a car with a single discharge bay and a capacity of 2,600 cubic feet. A two-bay design was also available with a capacity of 3,660 cubic feet.

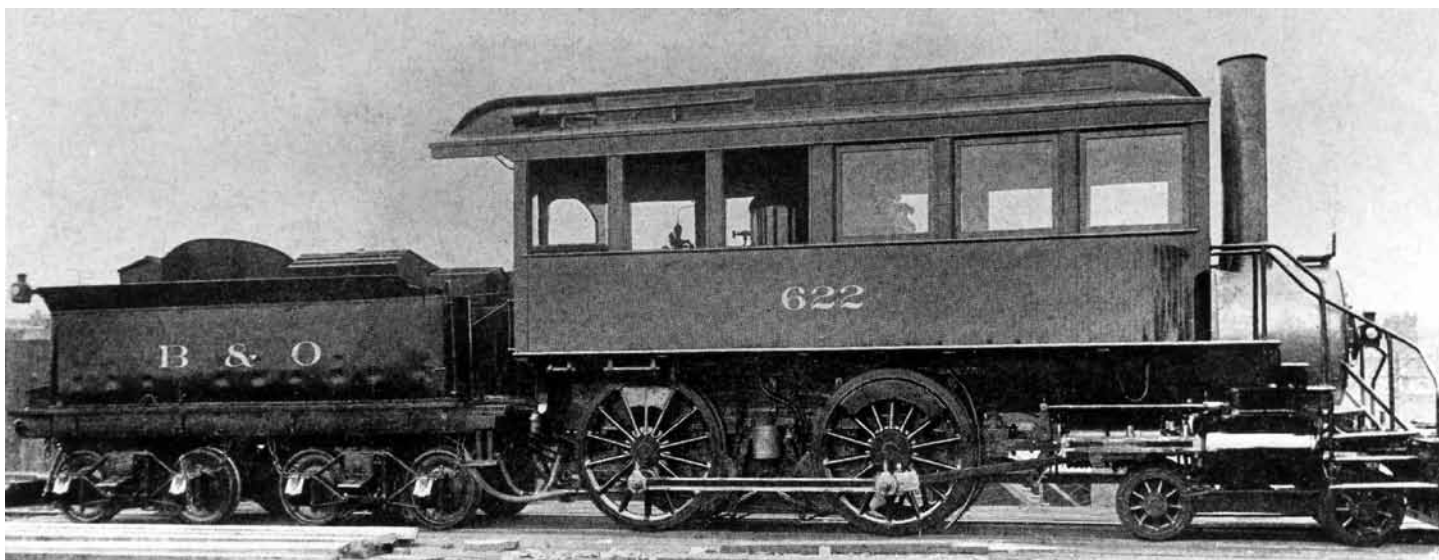
Baltimore & Ohio 4-4-0 Number 622, built at Mount Clare shops in January 1869 as 2nd Number 122 with 17" x 24" cylinders, 64" drivers, 140 lbs pressure, and 78,000 lbs weight, became Number 622 in 1884, and was converted to an inspection engine in 1902. According to Edson it was retired by 1897, but its conversion was covered in trade and general press in July 1902. Press mentions continued until 1904. It was off the roster by 1912. Note that there is no headlight installed in this photo. Its steam dome can be clearly seen through the first open window, which is into the cab. According to press reports it had a pilot on the rear of the tender, but this is not seen in this photo. Also note the different finishes of the smokebox, cylinders and stack. The drawing on the third page calls for Russia Iron only on the smokebox, helping to account for the differences. (B&O Railroad Museum collection)

The drawing of B&O Number 622 illustrates many of the features of such conversions. The bodywork has three windows for the passenger compartment, with a partition between that area and the back three windows for the crew's cab. These partitions usually had windows in them to allow the crew a view forward, at least on the engineer's side. Some had a rest room on the fireman's side in front of the partition.

The boiler was given extra lagging and an insulating air space was left between it and the cover over the boiler that was in the center. The floor as well as the boiler's covering was carpeted, and there was

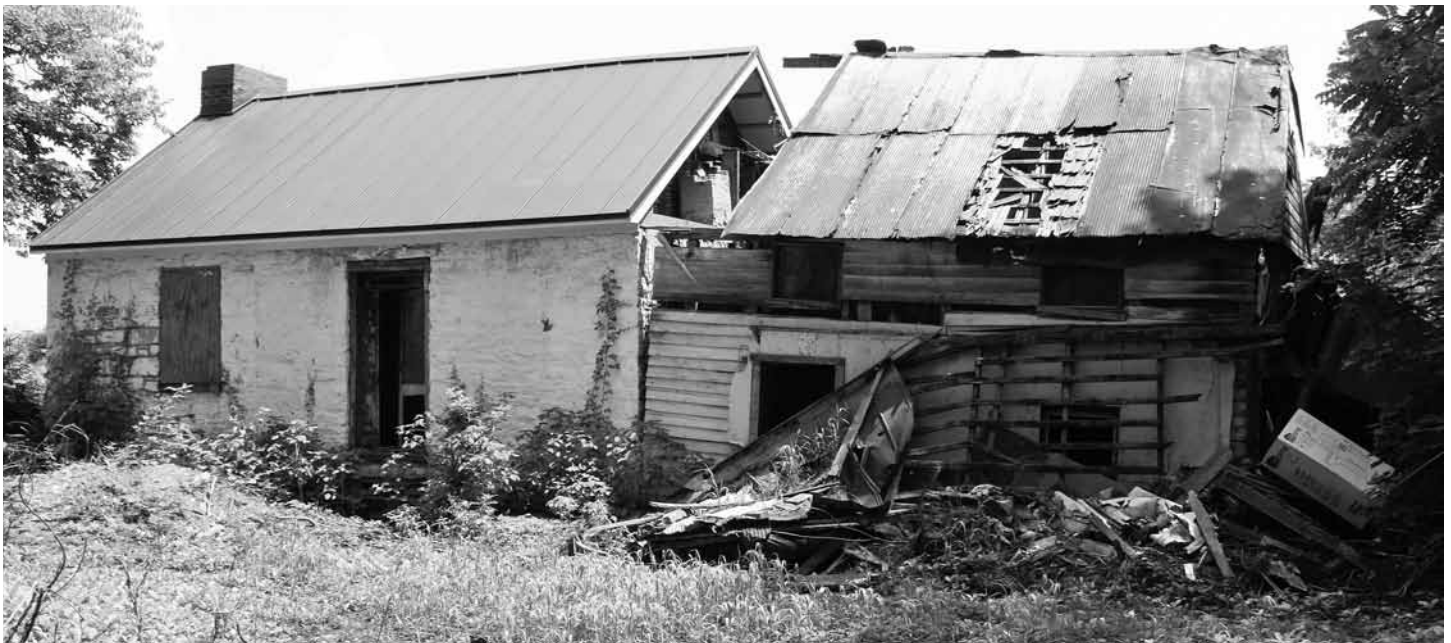
Duffields Station is open to some inspection on its north (back) side, where volunteers went in in 2008 to put a new tin roof on the stone segment of the building. The wooden section is probably beyond repair.
